CREEKS, BROOKS AND RIVERS
IN
ROCKLAND COUNTY, NEW YORK
and
Their Relation to Planning For the Future

UNITED STATES DEPARTMENT OF THE INTERIOR
GEOLOGICAL SURVEY

Prepared in cooperation with
the Board of Supervisors, Rockland County, New York

BULLETIN NO. 6

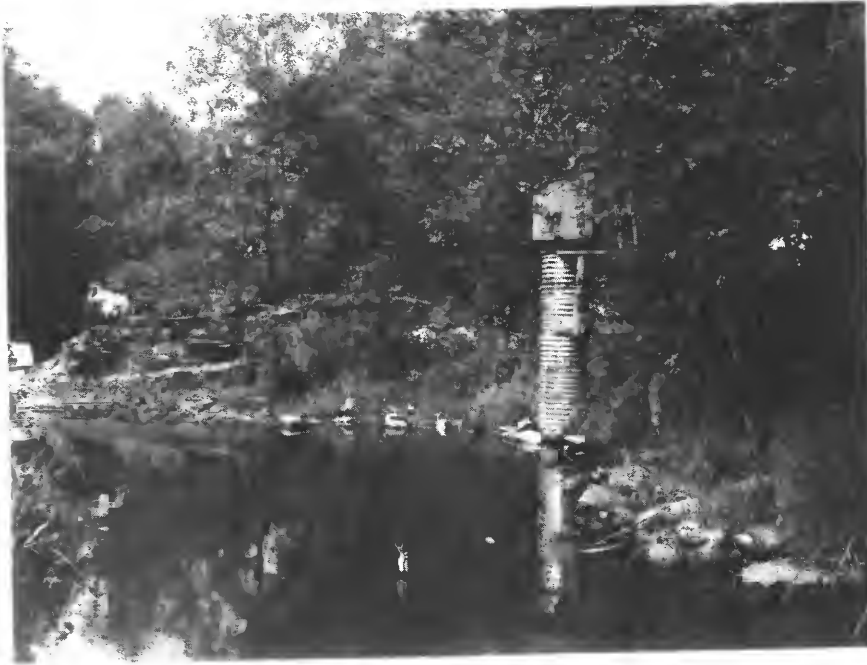
Typical Rockland County Stream-gaging Station
